# Manhole Inspection Summary

Manhole # S35AA1025MH

Insp Date: **1/18/07 11:01 AM**

**Location** Address: **340 UNIVERSITY PKWY**

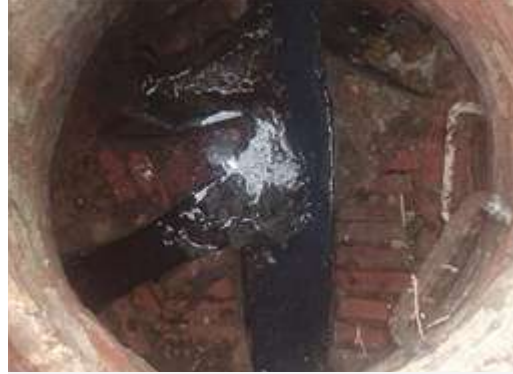
Top View

**Steps** Count: **2** Missing: **0** ☒ **Corroded**

**Surcharge** ☒ **Evidence Of Surcharge** Depth: **1.5** (ft.) ☐ Active Surcharge Present

Corroded steps. Evidence of srucahrge -  
Bench debris. Channel debris.

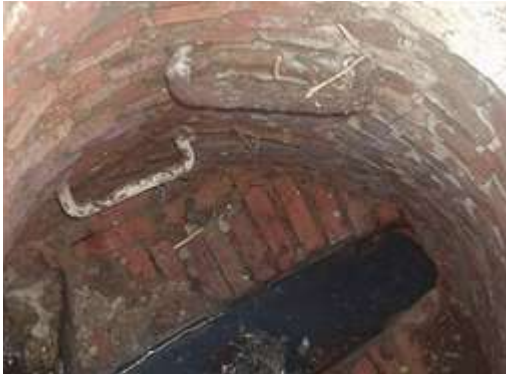
Defect

Barrel infiltration.

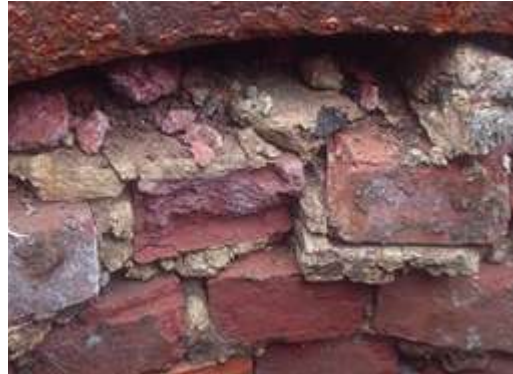
Defect

Condition: ☐ Sound ☐ Cracked ☐ Root Intrusion ☒ **Loose Brick** ☒ **Deteriorated**

Infiltration: ☐ None ☒ **Joint** ☐ Cracks ☐ Mortar ☐ Roots ☒ **Wall**

Adjustment deterioration, loose brick and  
infiltration.

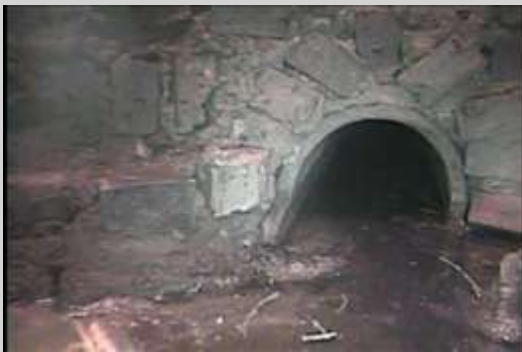
### 8 in. Circular Gravity Sewer Pipe Out @ 12 O'Clock

Barrel deterioration and infiltration. Channel deterioration.

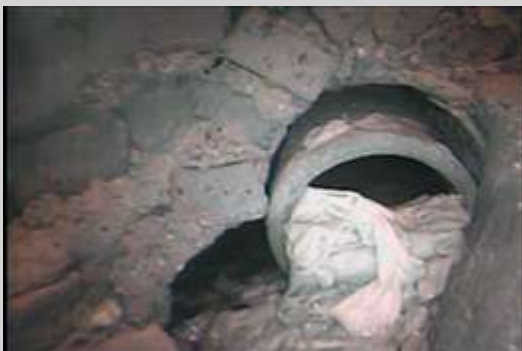
### 6 in. Circular Gravity Sewer Pipe In @ 2 O'Clock

hole near pipe

Infiltration: **None** Pipe Seal Cond: **Cracked**

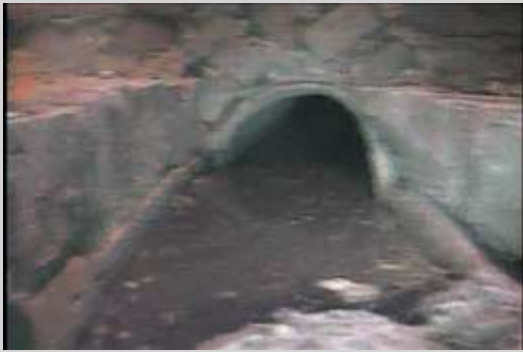
Pipe In @ 6 O'Clock

Channel deterioration.

Infiltration: **Evidence** Pipe Seal Cond: **Cracked**

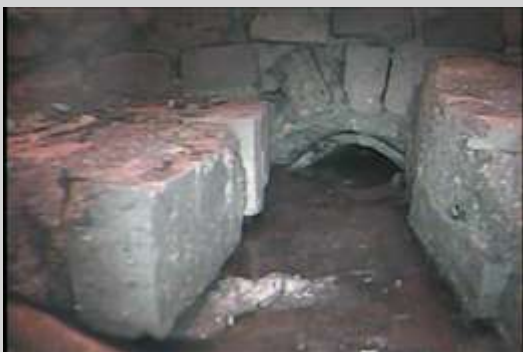
Pipe In @ 8 O'Clock

Barrel deterioration and infiltration. Channel deterioration.

Infiltration: **Evidence** Pipe Seal Cond: **Unknown**

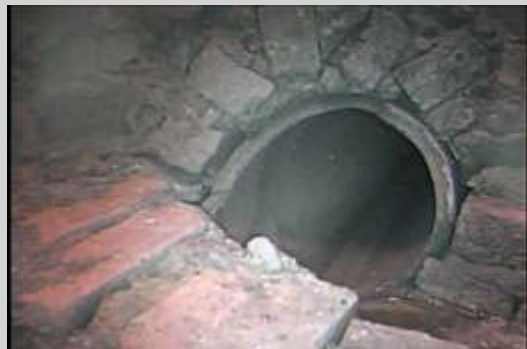
Pipe In @ 10 O'Clock

Barrel deterioration and infiltration. Bench and Channel deterioration.

Infiltration: **Evidence**

Pipe Seal Cond: **Broken**
